DEPARTMENT OF TRANSPORTATION

Contract #: 04-0120F4Cty: SF/ALA Rte: 80 PM: 13.2/13.9File #: 69.28**WELDING INSPECTION REPORT****Resident Engineer:** Siegenthaler, Peter**Address:** 333 Burma Road**City:** Oakland, CA 94607**Report No:** WIR-021484**Date Inspected:** 06-Mar-2011**Project Name:** SAS Superstructure**OSM Arrival Time:** 1500**Prime Contractor:** American Bridge/Fluor Enterprises, a JV**OSM Departure Time:** 300**Contractor:** Zhenhua Port Machinery Company, Ltd (ZPMC), Changxing Island **Location:** Shanghai, China**CWI Name:** See Below**CWI Present:** Yes No**Inspected CWI report:** Yes No N/A**Rod Oven in Use:** Yes No N/A**Electrode to specification:** Yes No N/A**Weld Procedures Followed:** Yes No N/A**Qualified Welders:** Yes No N/A**Verified Joint Fit-up:** Yes No N/A**Approved Drawings:** Yes No N/A**Approved WPS:** Yes No N/A**Delayed / Cancelled:** Yes No N/A**Bridge No:** 34-0006**Component:** OBG & Tower**Summary of Items Observed:**

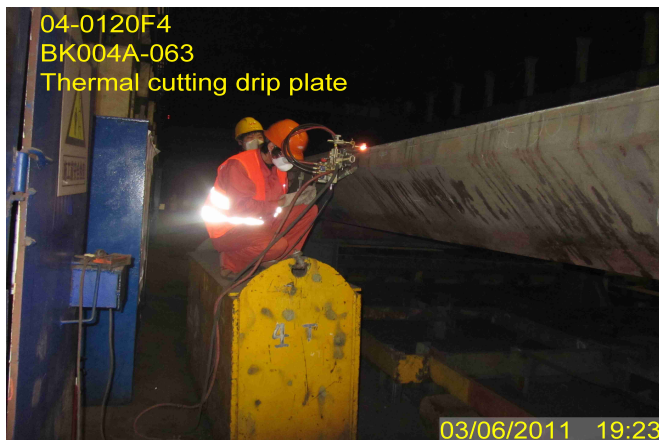
This QA inspector observed ZPMC personnel performing thermal cutting/ trimming of drip plate on bike path assembly BK004A-063 using mechanical guided track torch. The following digital picture illustrates thermal cutting in process.
